**BIG LAKE DAM
JEFFERSON COUNTY, MISSOURI
MO. 30457**

**PHASE I INSPECTION REPORT
NATIONAL DAM SAFETY PROGRAM**

JULY 1981

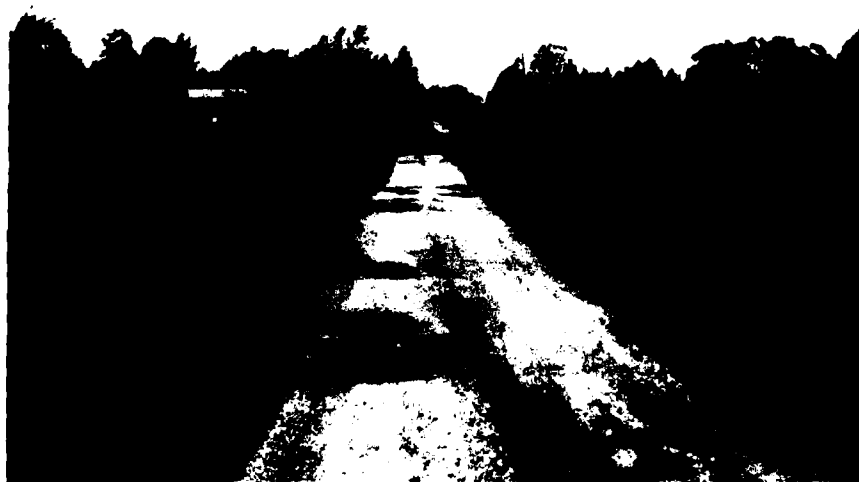
The top of dam supports a gravel access road used by the local residents to gain access to their homes (see Photo 2). Evidence of some asphalt paving was observed. Outside of the access road, the top of dam is covered by an unmaintained grass cover. The combination of the gravel surfacing and vegetative covering appeared to provide adequate erosion protection against surface runoff, for no erosion was evident. No major damage due to vehicular traffic was seen. Several small potholes were observed; however, on the day of the inspection, a maintenance crew filled in the potholes with asphalt. No depressions or cracks indicating a settlement of the embankment were apparent. The variation in elevation across the top of dam did not appear to be due to an instability of the embankment. No significant deviation in the horizontal alignment was apparent. According to Mr. Shy, the dam has never been overtopped and no evidence indicating the contrary was observed.

Photo 2 - View of the top of dam from the right abutment.

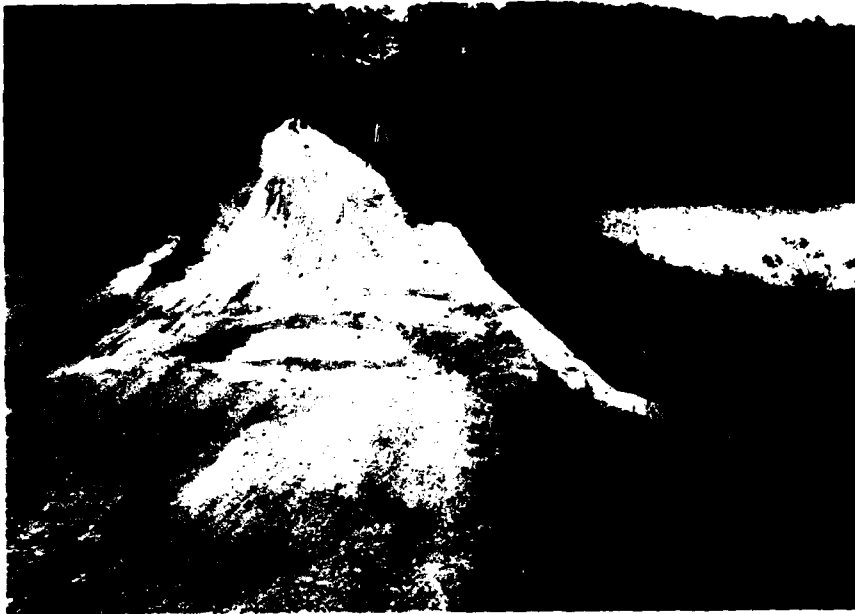
Photo 5 - View of the spillway broad-crested weir and concrete wall inlet looking from the left abutment.

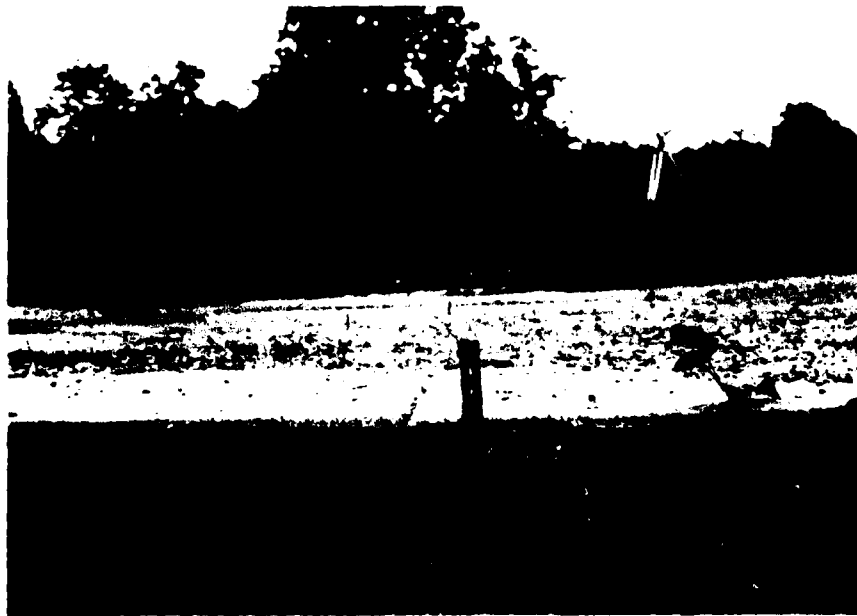
There are several top to bottom cracks in the concrete wall of the spillway inlet with separation and displacement of 1/4 to 1/2 inch (see Photo 6). The cracks are due probably to differential settlement of the wall. The surface of the concrete appears sound with no excessive weathering evident. The gravel surfacing of the broad-crested weir is generally smooth and uniform with the exception of one minor depression due probably to vehicular traffic (see Photo 5). The bottom of the discharge channel immediately downstream of the spillway weir is a composite of bare earth marked with erosional rivulets and pieces of concrete (see Photo 7). As the channel begins to bend towards the downstream channel, a mass of dumped debris covers the start of the heavily eroded V-shaped cross section, which has steep bare earth side slopes (see Photo 8). The side slopes are unprotected as the channel descends toward the downstream channel (see Photo 9). A second mass of dumped debris was observed in the discharge channel at about halfway down the channel.

1. The cracks in the inlet wall of the spillway do not appear to be a hazard to the stability of the spillway at the present time. Nonetheless, as the displacement along the cracks increases with time, the spillway, due to its weakened condition, will be more susceptible to damage from future flows.

Photo 6 - Close-up view of a crack in the concrete wall inlet of the spillway.

2. The cracking and displacement of the concrete of the spillway control section should be closely monitored and repairs made when deemed necessary by a qualified professional engineer.

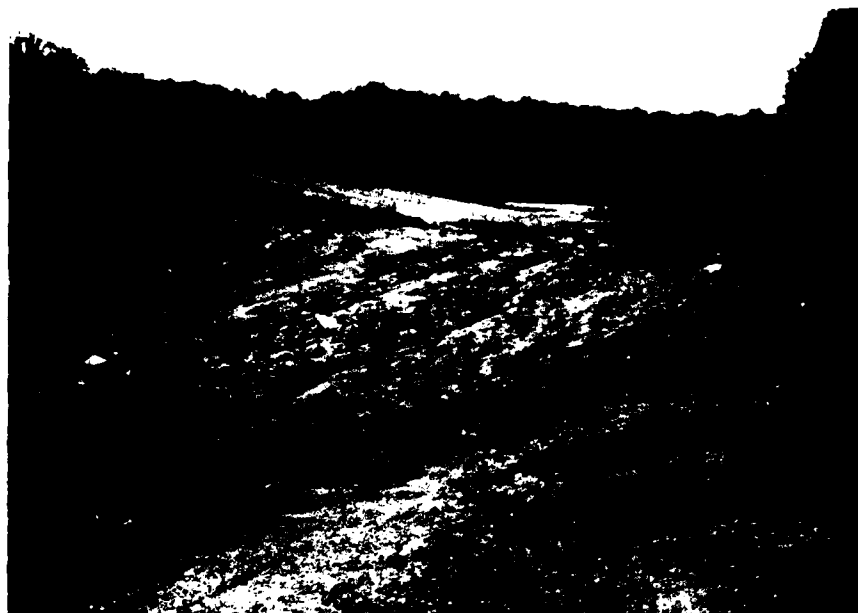
2. The unprotected earth surfaces of the spillway discharge channel present a real threat to the safety of the spillway. It is anticipated that future flows through the spillway could cause erosion severe enough to jeopardize the stability of the spillway and therefore the safety of the dam.

Photo 7 - View of the spillway discharge channel. Note the erosion and concrete debris.

3. The eroded spillway discharge channel should be repaired and stabilized. This should also include the removal of all randomly dumped materials in the channel.
